Archaeological Observation at St Mary's Church, Tysoe, Warwickshire

Report 0637

July 2006

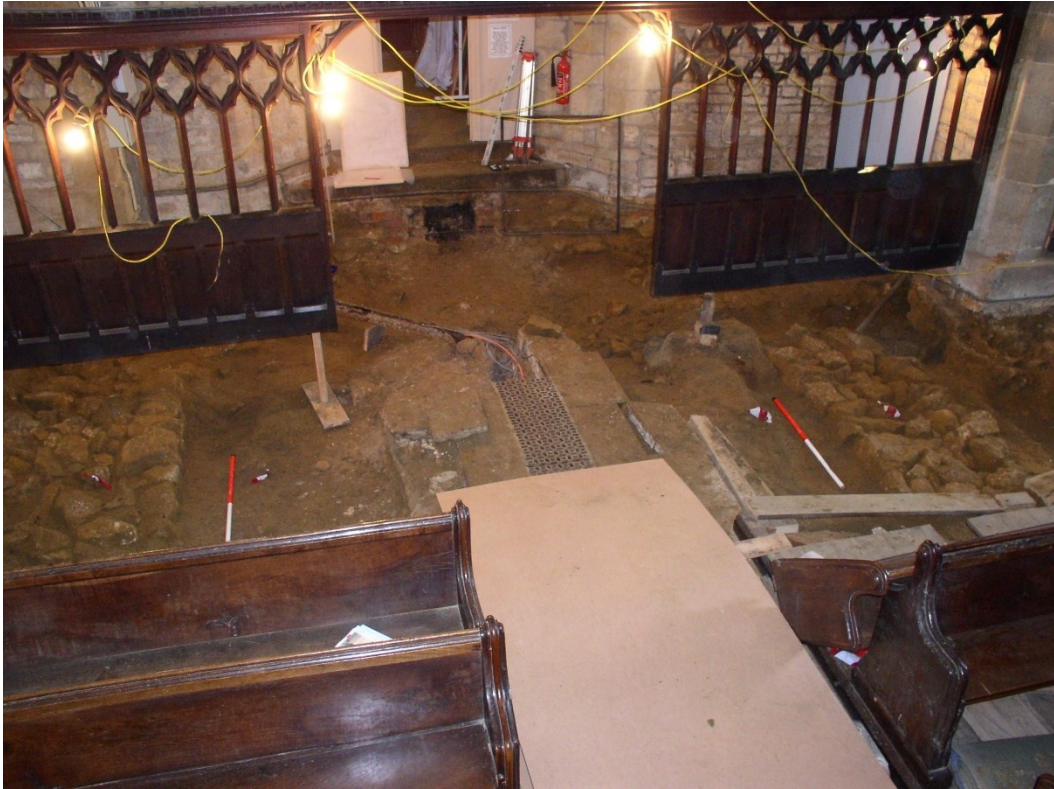
Fig. 3: Overall view of observed area

4.1 The internal observed area was c.5.2m x 8.5m in extent at the western end of the nave plus a trench across the north aisle (Figs. 1, 3). Observation commenced after removal by contractors of the pews and the suspended timber floor on which they were supported, and the flagstone floor in the remainder of the working area.

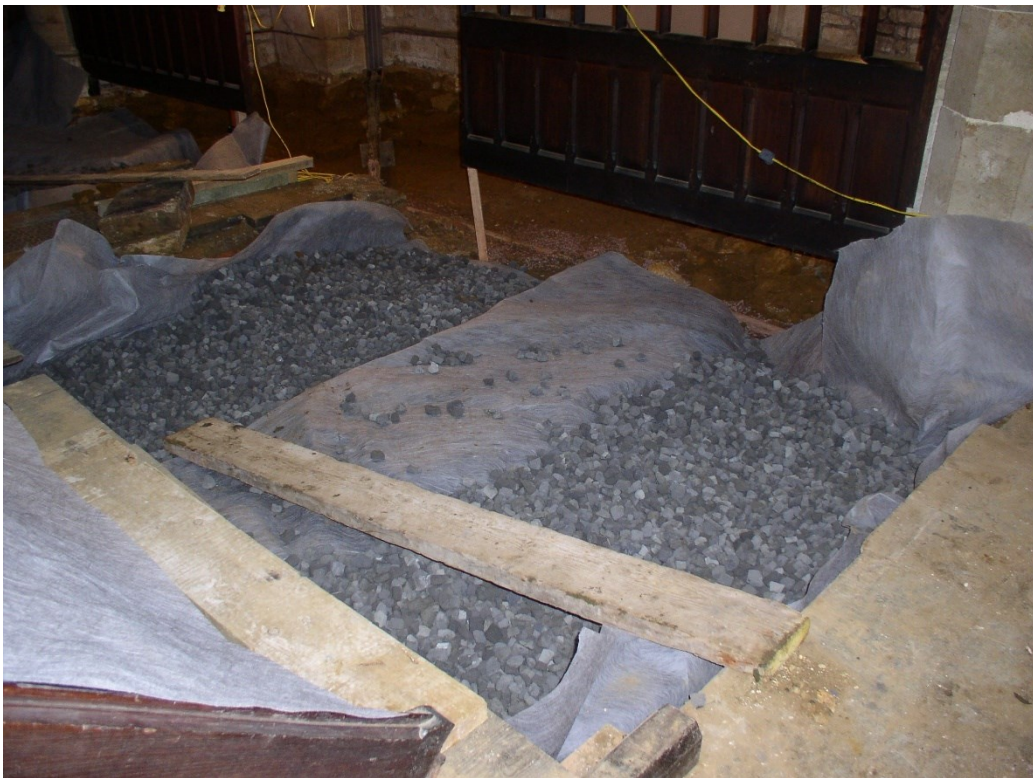
Fig. 4: Preservation measures below floor of new circulating area

4.5 After confirmation of the extent and significance of the newly exposed remains in the circulating area, and excavation of the less sensitive deposits to full formation depth of c.0.45m, a further change was made. It was agreed that the need for insulation below the floor of the circulating area (which forms only a small part of the nave) was of lesser importance than the desirability of preserving the remaining archaeological features (principally wall foundations) *in situ*, and that a reduction in the sub-base over them was acceptable. After archaeological recording the *in situ* remains were covered with a Terram membrane before construction of the new floor (Fig. 4). In the relatively confined toilet and utility rooms it was necessary to maintain the insulating properties of the floor, and in these areas archaeological remains were removed as necessary, mostly by archaeological staff, after recording. The minimum level was generally c.0.35m below floor level, but due to the uneven nature of the rubble of which the archaeological features were formed it was often necessary to exceed this to achieve the required minimum.

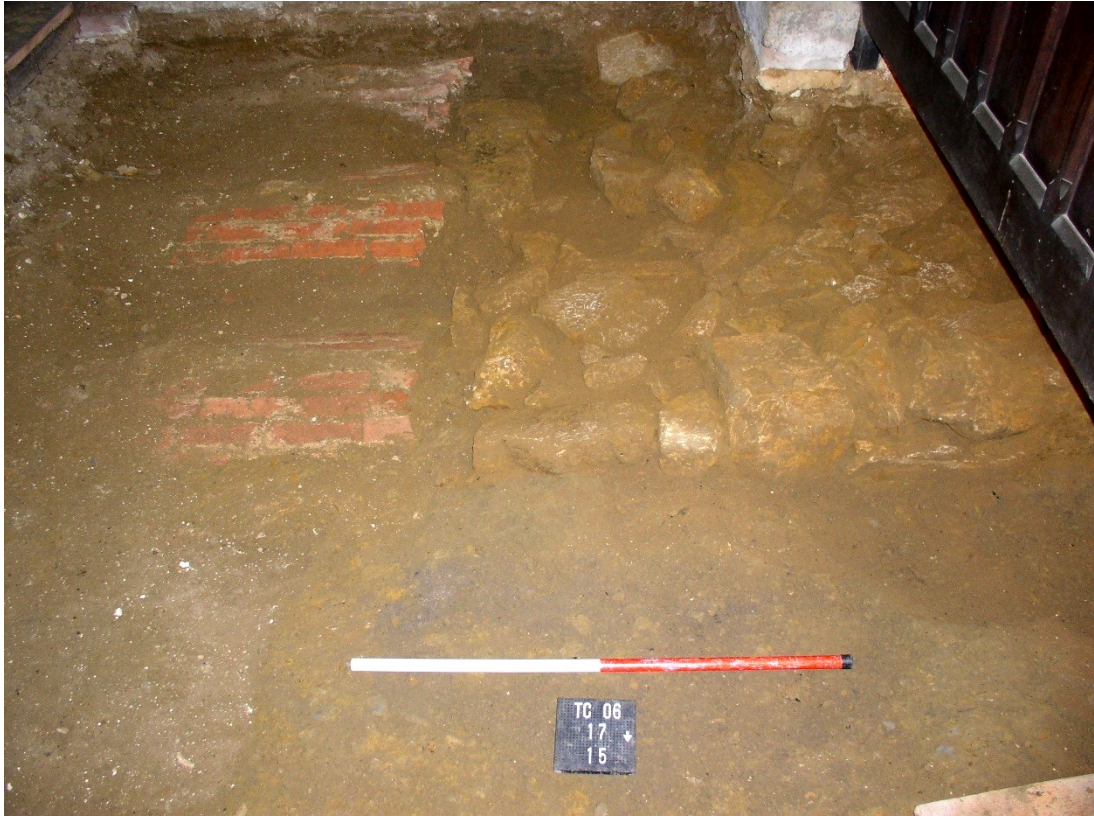
Fig. 7: Wall foundation 17, layer 15 and brick vaults

4.8 Foundation 17 consisted of unmortared Hornton stone (ironstone) rubble in a greyish brown sandy silt clay matrix, with a roughly coursed north face which survived to a maximum height of 107.10m AOD and width of *c.*1.4m. East of the west respond of the south arcade wall it merged with similar Hornton stone rubble foundations (18) and (19) from which it was indistinguishable.

4.25 A row of three post-medieval, probably 18th-or early 19th-century, brick burial vaults were found in the south east corner of the observed area (Fig. 7). Their extent was established and they were partially exposed, but it was not considered necessary to record them fully as they were preserved in situ below the new floor. The north-west corner of a further brick vault (13) was found immediately to the north of the heating duct. It was slightly below the intended formation depth and could not be investigated, but its presence was confirmed by a small exploratory excavation. It appeared that the top had been removed by the Victorian heating duct, and it is assumed it was emptied and backfilled when the duct was installed.

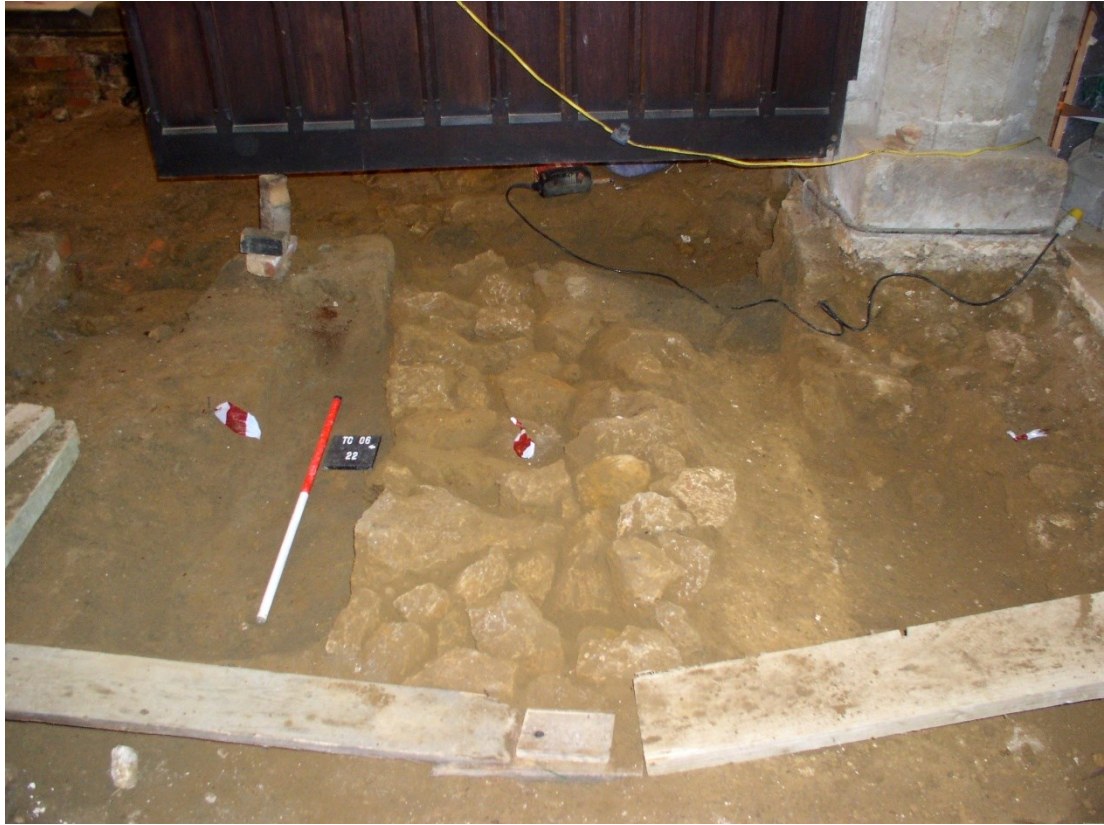
Fig. 9: Wall foundation 22/25

4.9 Foundation 22 stood to a level of 106.98m AOD and width of *c.*1.4m. It was of unmortared random Hornton stone rubble in a brown silty clay matrix except for its north side where there was a deposit of sandy mortar (25) which abutted the foundation of the existing north arcade respond and continued east with a very straight north edge. The mortar was underlain by masonry, although this was below formation depth and its nature could not be confirmed. It suggests that the wall originally had dressed facing stones on the north side, which had been removed for re-use elsewhere. A single sherd of ?12th-century pottery was recovered from this area (context 20, the junction of 8 and 22). Ratkai (Appendix C) comments that the sherd could also conceivably be early to middle Anglo-Saxon in date, although given that the assemblage overall appears to be from the 12th to 13th centuries this is not likely. Even if it were to be of that period it would undoubtedly be a residual find in a later foundation; it can be confidently assumed that Tysoe would not have possessed a substantial stone church at such an early date.

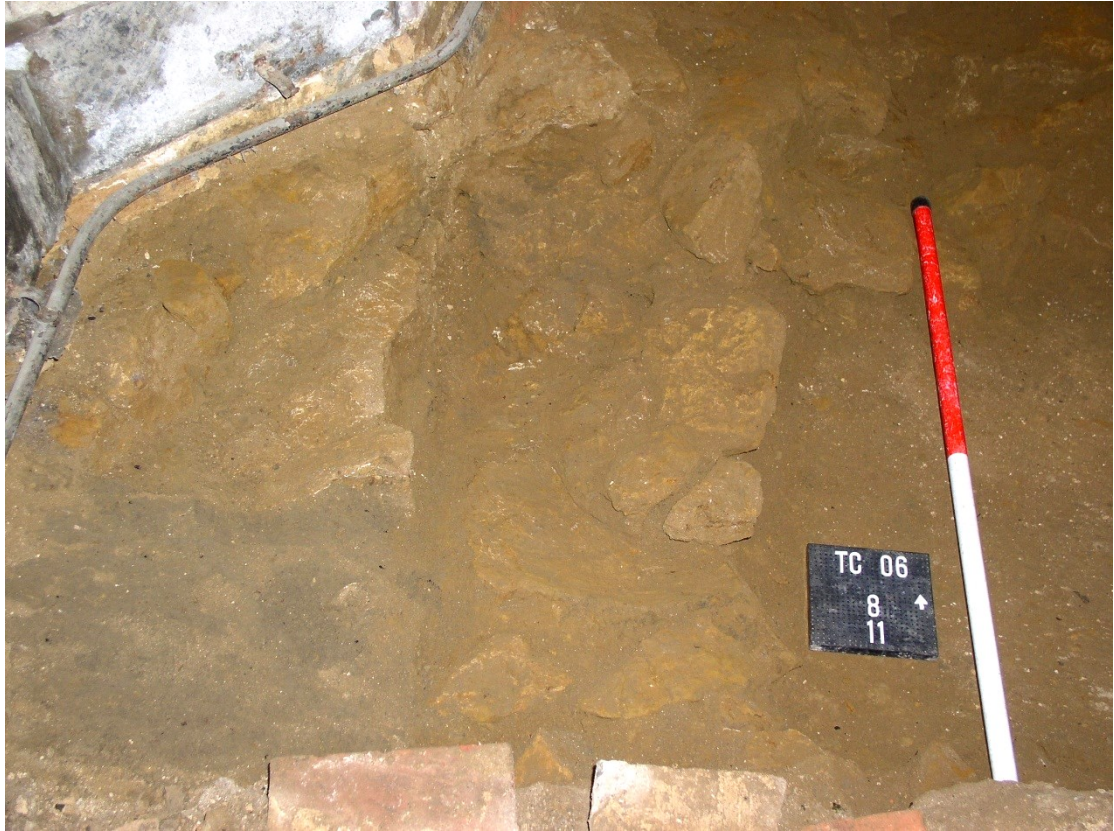
Fig. 11: Wall foundations 8, 11

4.11 Foundation 8 was formed of Hornton stone rubble. Its surviving width was generally only *c.*0.4m wide, although the extent of the masonry at the junctions with 17 and 22/25 indicates an original width of between 1.6m and 1.7m. The highest

4.14 The foundations of the east wall of the present tower, which also forms the west wall of the nave, were partially exposed and recorded to the north (11) and south (6) of the doorway. These were of Hornton stone rubble, and in the case of the former appeared to be later than the early north-south foundation 8. Apart from exposure they were unaffected by the present works.

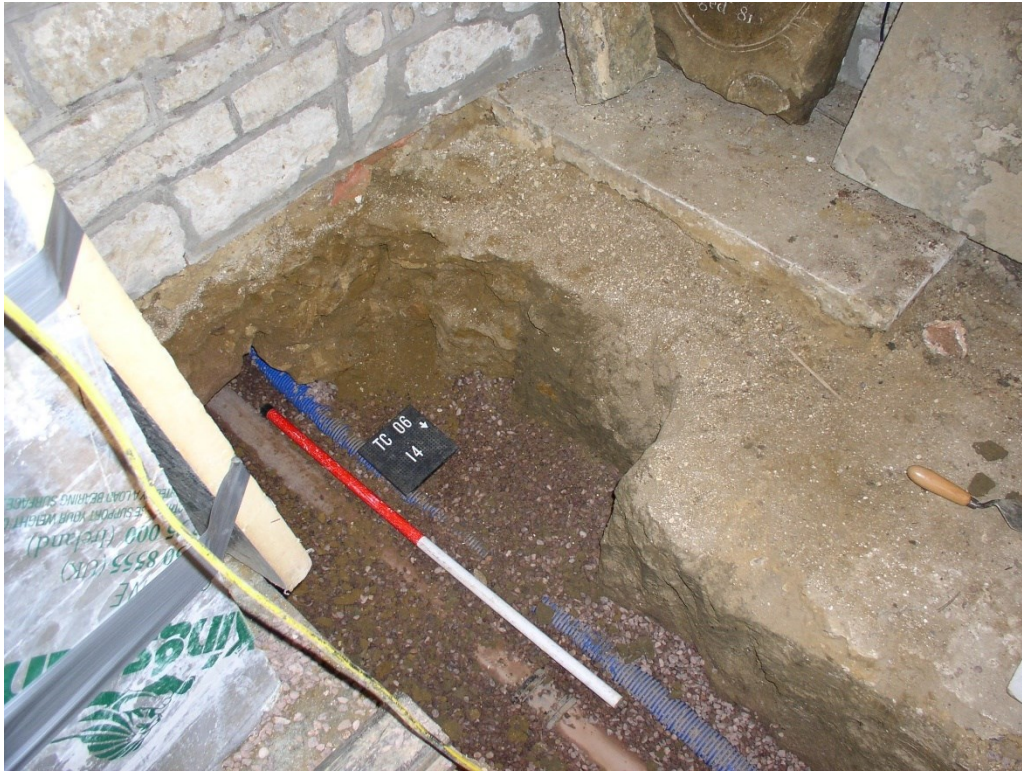
Fig. 13: Service trench, north aisle - foundation 14 (north arcade wall) from north-east

4.15 The foundations of the western end of the north arcade wall were noted in the service trench across the north aisle (14; Fig. 13), and were of rubble similar to that recorded elsewhere. At the northern edge of the area observed, continuing the alignment of 14 eastwards, were an apparent southwards continuation of the rubble foundation (33) and a deposit of fill (24). Neither of these could be investigated adequately.

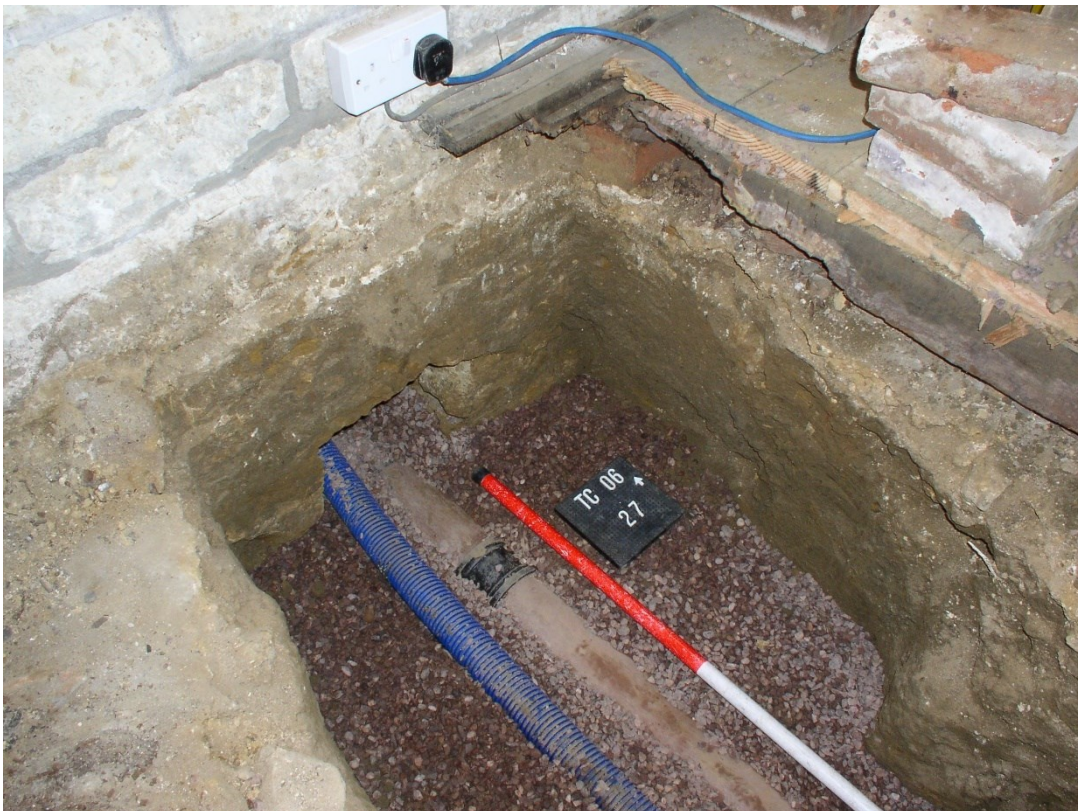
Fig. 14: Service trench, north aisle - foundation 27 (north wall) from south-west

4.24 The foundations of the north wall of the north aisle (the external wall of the church) were noted in the service trench across the north aisle (27). These were well-constructed coursed masonry only slightly wider than the wall above (Fig. 14). A grey silty clay (29) make-up layer was found immediately below the present floor of the north aisle; one sherd of 12th- to 13th-century pottery was recovered from it.

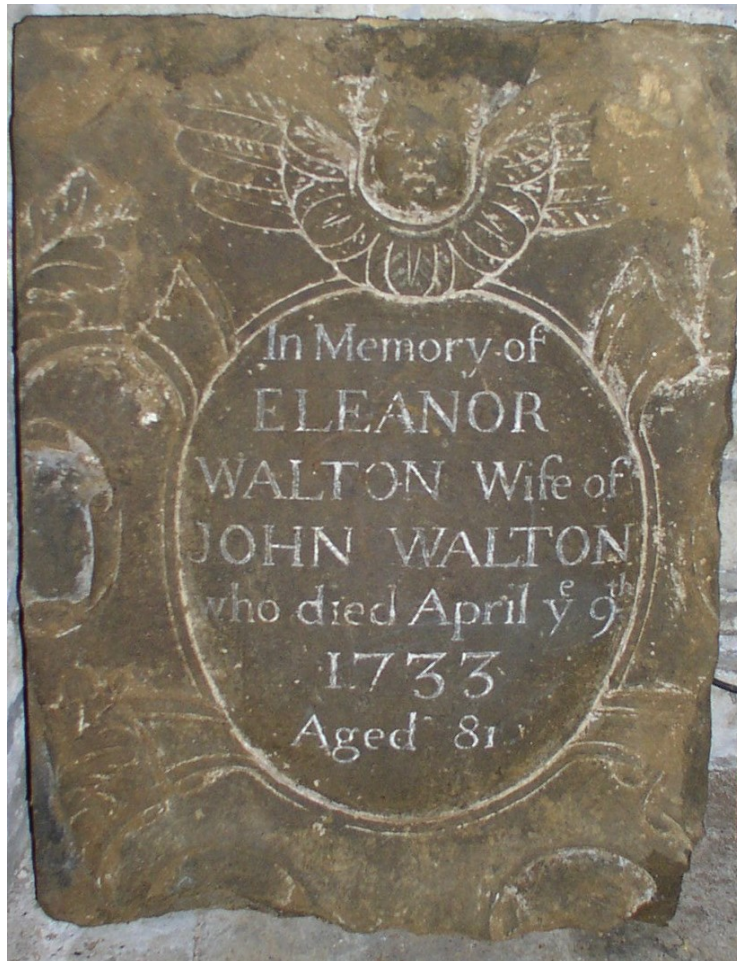
Fig. 15: Re-used memorial stone recovered from floor

4.28 Set on levelling layer 5 within the nave, except where occupied by pews, was a flagstone floor (1) incorporating one re-used 18th-century memorial stone laid face down at the west end between the screen and the tower (Fig.15). The flags were set on a bed of light brown mortar. Similar flags set on light brown mortar also formed the floor of the north aisle, although there they were set directly on a clay make-up layer (29). The floor was probably contemporary with a substantial heating duct running east-west along the centre line of the floor (3). This had a brick base and sides, partially capped with stone but mostly with a cast iron grille set in the floor. It was set in a trench (2) cut slightly into the underlying layers and features, the backfill on the south side of which included numerous stone fragments (4). The western (stone capped) end of the duct contained substantial quantities of soot, and further east it had been re-used to take electricity cables. The floor and heating appear Victorian, possibly from Scott's refurbishment although the heating could be a later insertion.
